EQ SYSTEMS PUMP & MANIFOLD FLUID LEAKAGE

October 2021

Applicable to pumps #3195KS, 2542KS, 3218, 3195, 3043, 2390, 2532 and 2542. And manifold 4 function # 2723, 6 function # 2742 and 8 function # 2757

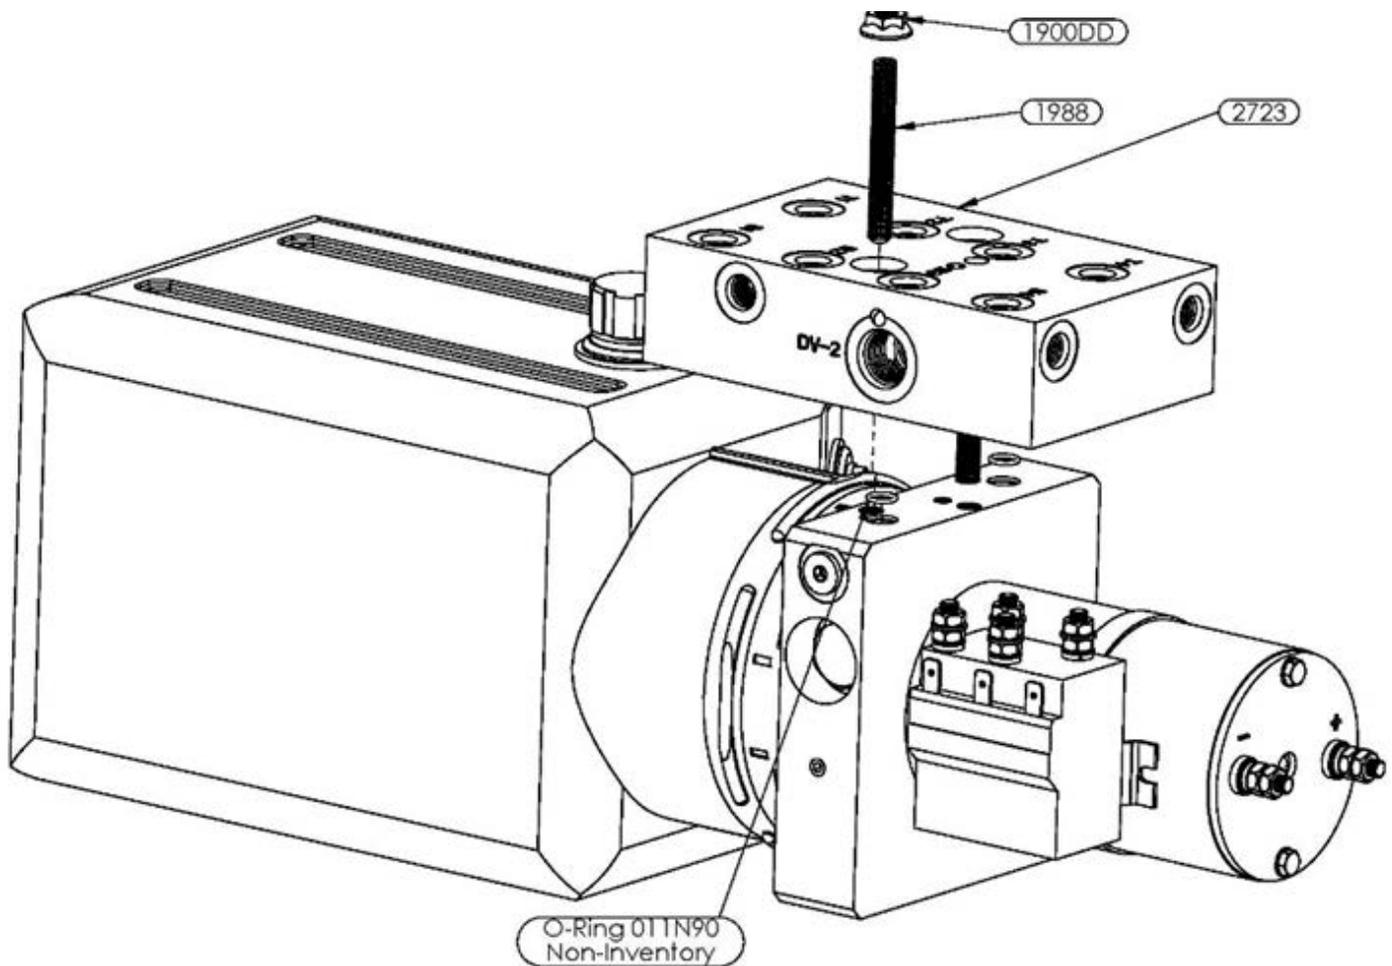
Addressing Fluid leakage from the joint/connection between the upper manifold and the lower assembly caused by missing or incorrectly installed o-rings, or the failure of the attachment studs and nuts. This may also allow fluid leakage up and around the attachment studs and nuts. This “issue” is corrected by removing the upper manifold from the lower assembly and replacing the o-rings (2) and then reattaching the manifold. The complete assembly is not to be replaced for this correction. Generally, this process is 1 hour or less.

There are two o-rings that seal the upper manifold to the lower ‘port plate’ of the lower assembly. These o-rings are to be installed into the counter bore of the fluid ports (see drawing). Note: the drawing shows only the manifold used for a four function (part # 2723) assembly the process is the same for 6 and 8 function manifolds.

2. Loosen and remove the nuts EQ #1900DD (generally there are two) that are present in the counterbores in the top of the manifold (see drawing). A ½ inch 6-point socket is used for this. If hose connections are made with 90-degree fittings it may be necessary to loosen and reposition or disconnect them.

3. After removing the nuts lift/remove the manifold from the lower assembly. If available or needed remove and replace the studs EQ #1988.
4. Remove o-rings from the lower assembly port plate, use a clean rag to wipe the surface of the lower assembly and manifold clean. Install new o-rings into the port counter bores assuring that they are fully seated in the groove. The use of grease is permitted to help hold them in place.

5. Reinstall the manifold down over the studs. Install the nuts EQ #1900DD. Alternately tighten to 18 LB-FT
6. If hose or fitting connections were loosened/removed reconnect/tighten.
7. Verify the fluid level in the reservoir add fluid if needed. Use Automatic transmission fluid, multipurpose or any of the Dexron/Mercon fluids.
8. Cycle the system extend and retract a couple of times to test and remove air from system.
